Slocan Integral Forestry Cooperative

Trozzo Creek 2020-2022

# Stream Flow & Water Quality Monitoring

July 2023

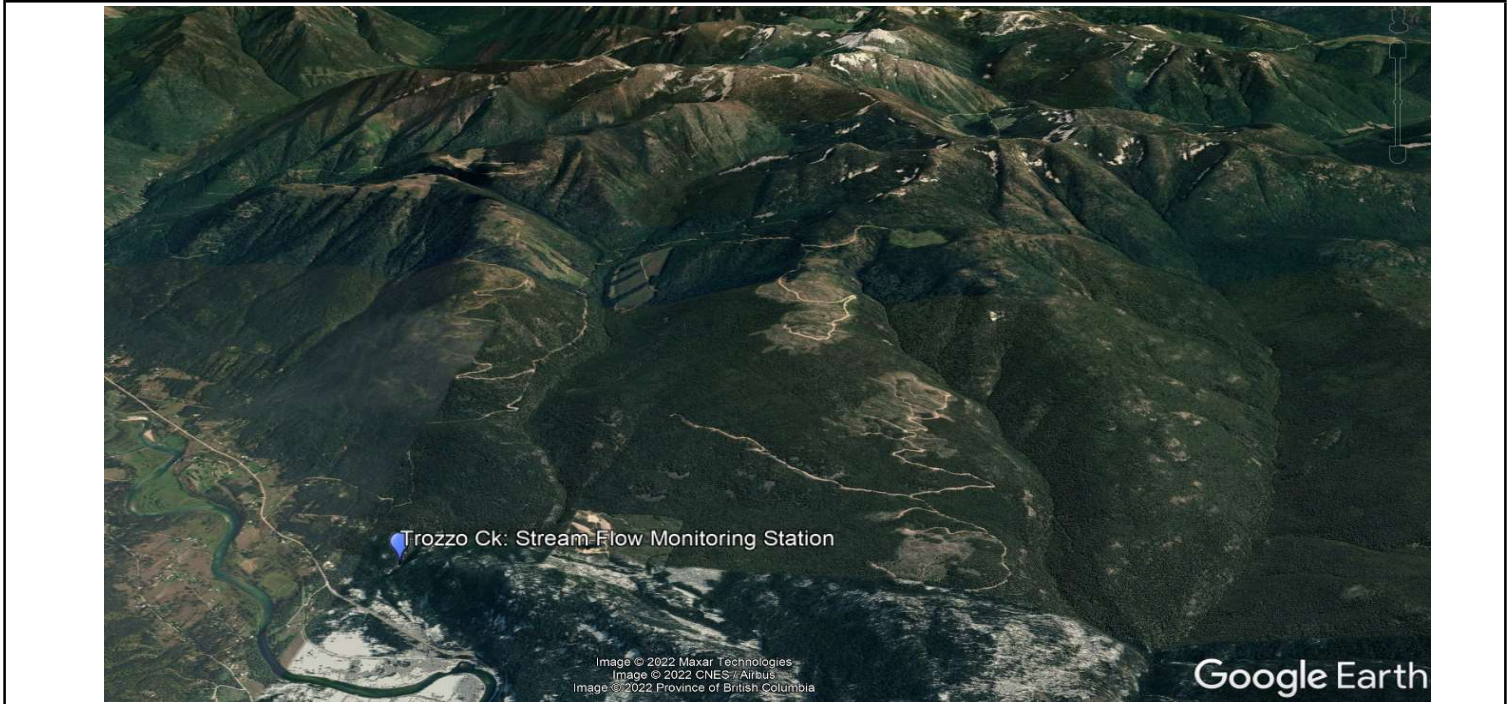
### i) Station or Watershed Image

Description of Location: The station is located at the upper most drinking water intake where the stream has been dammed using logs, rocks and gravel. The "upper station at rock" is ~10m upstream of the at dam station.

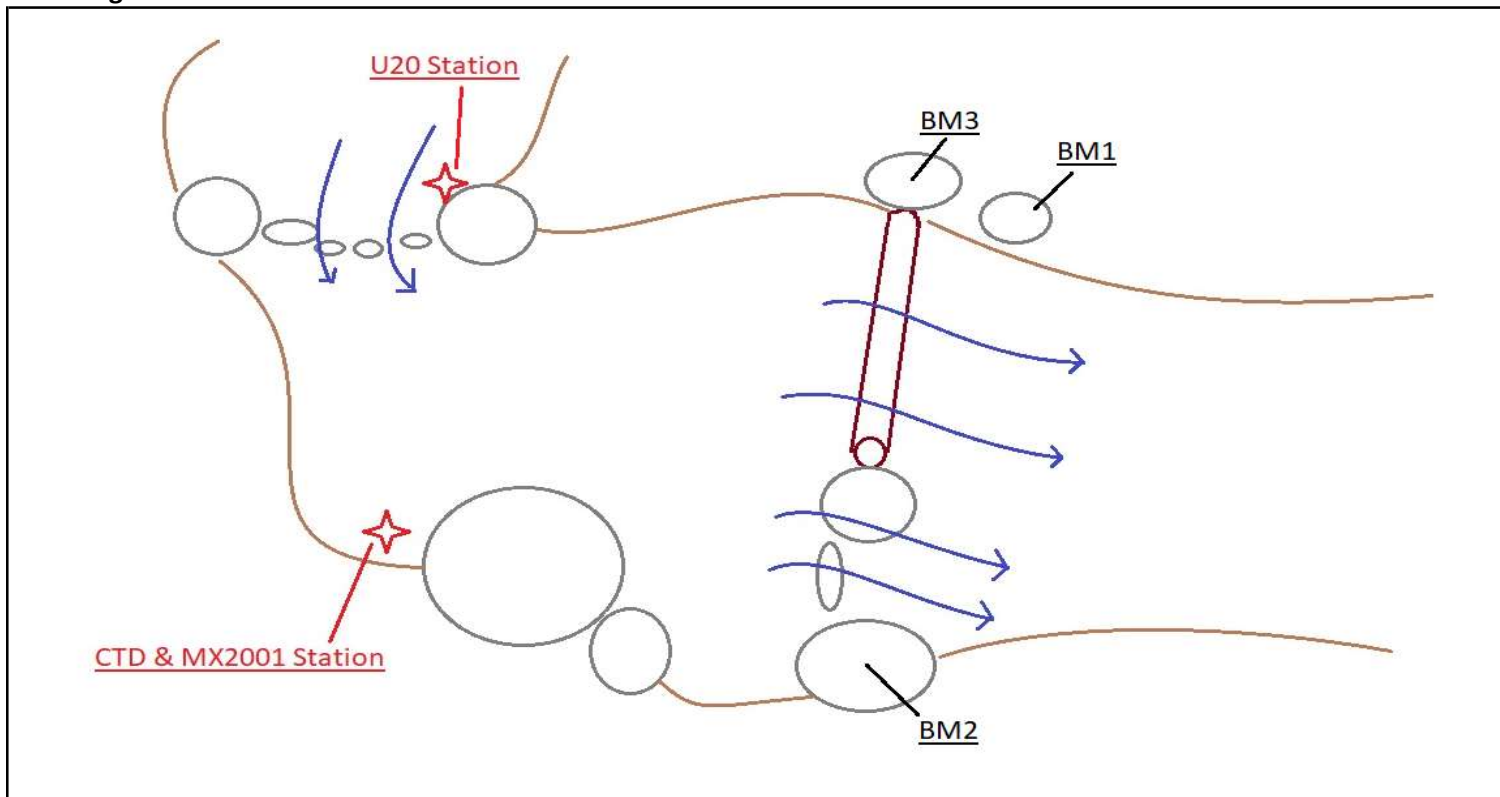
3) Sketch of site showing location of all equipment, benchmarks, channel morphology in the vicinity of the station including conditions.

The control at the at dam location consists of a log, rock and soil dam which is constructed by the water users at the site. The control was backed up partway through 2021 by the water users in order to raise the water level at the pool behind the dam so that their drinking water intakes would remain submerged. Over time, the sand that the water users used to raise the dam had washed away, effectively lowering the control. The control at the upper station at rock consisted of naturally placed rocks, but the pool formed by the control filled with sediment which buried the sensor. The control was destroyed in trying to access the buried sensor.

The channel is steep at the location and consists of gravel and large loose rocks. The channel width down stream of the station is relatively consistent at approximately three meters wide, though the stream does have locations where the width is smaller. Due to the steepness of the stream, the streambed is expected to shift during freshets. In addition, large wood debris is present in the stream.

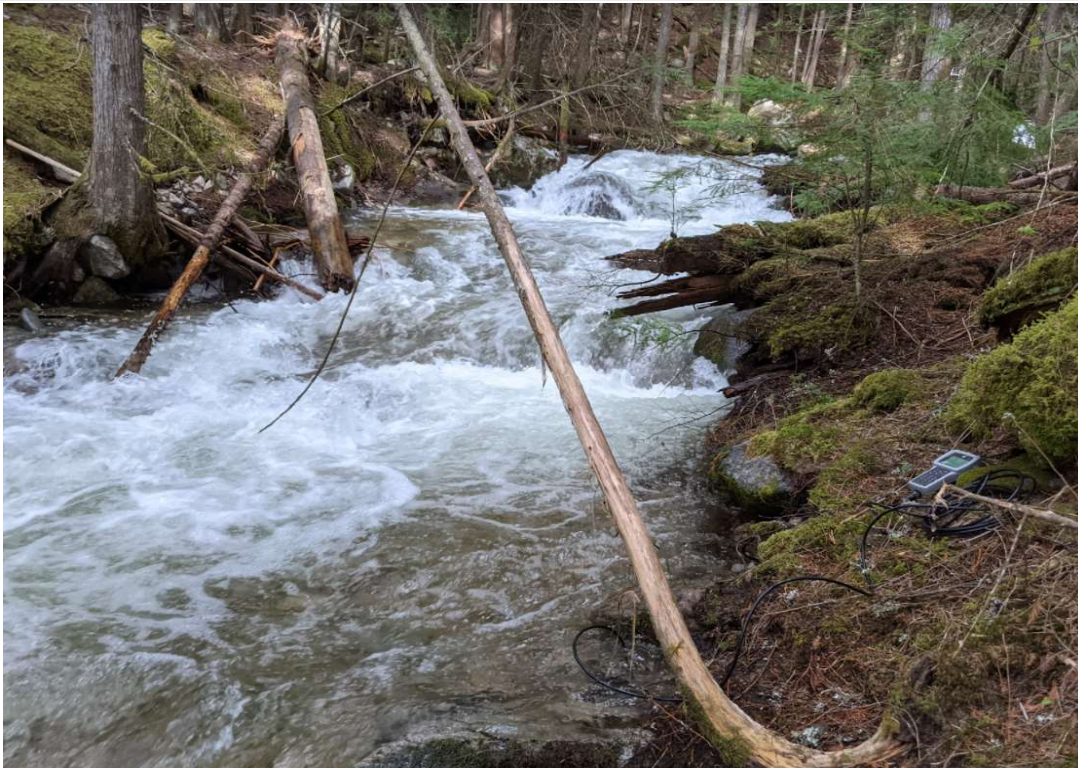
#### 4.3) Digital photographs showing sensor placement during dilution measurements.

mid-section method was used where possible, but dilution measurements were conducted at high flows when the stream could not be waded.

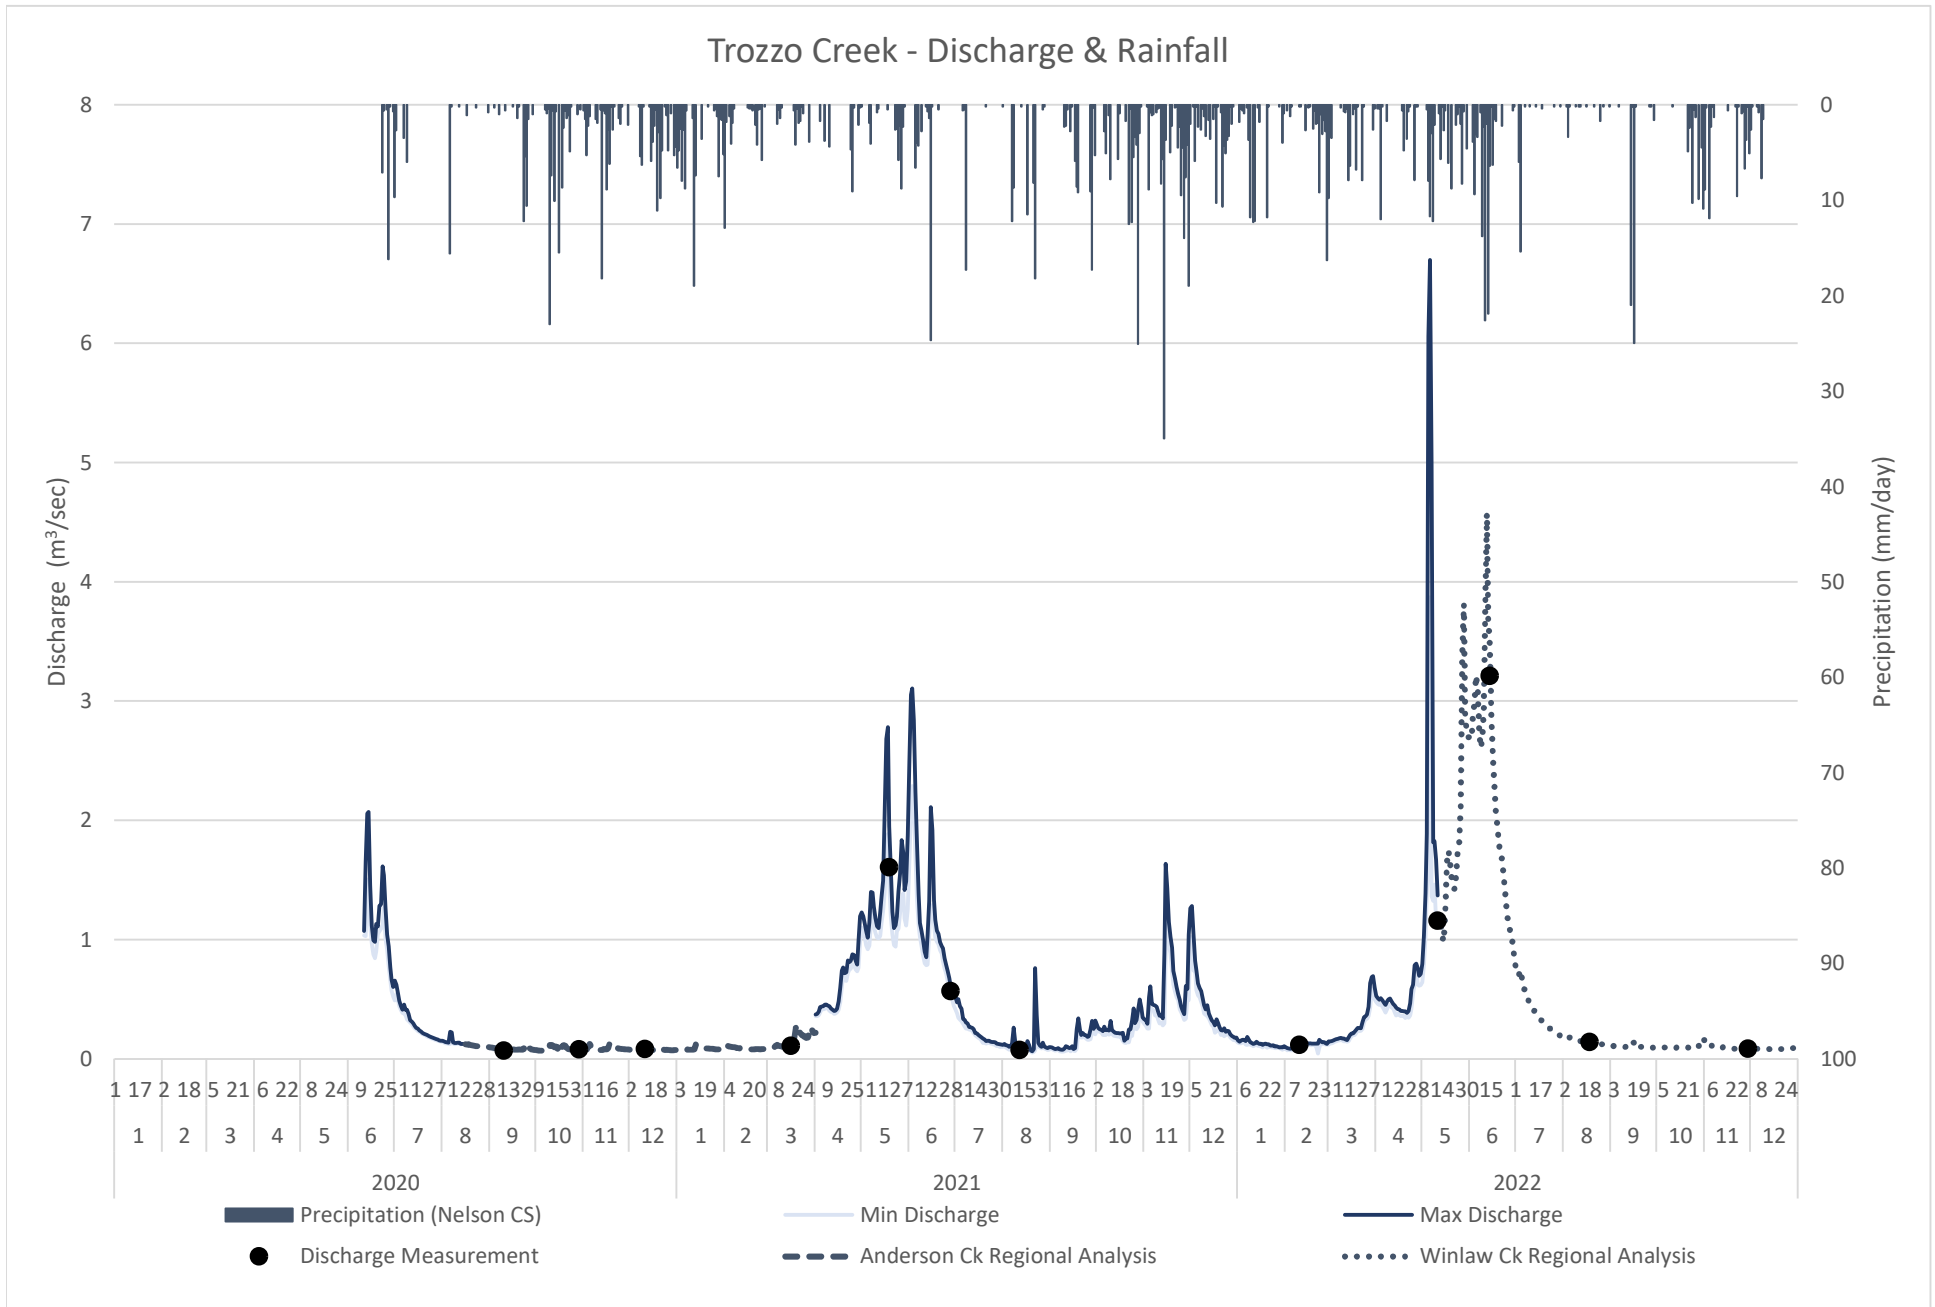
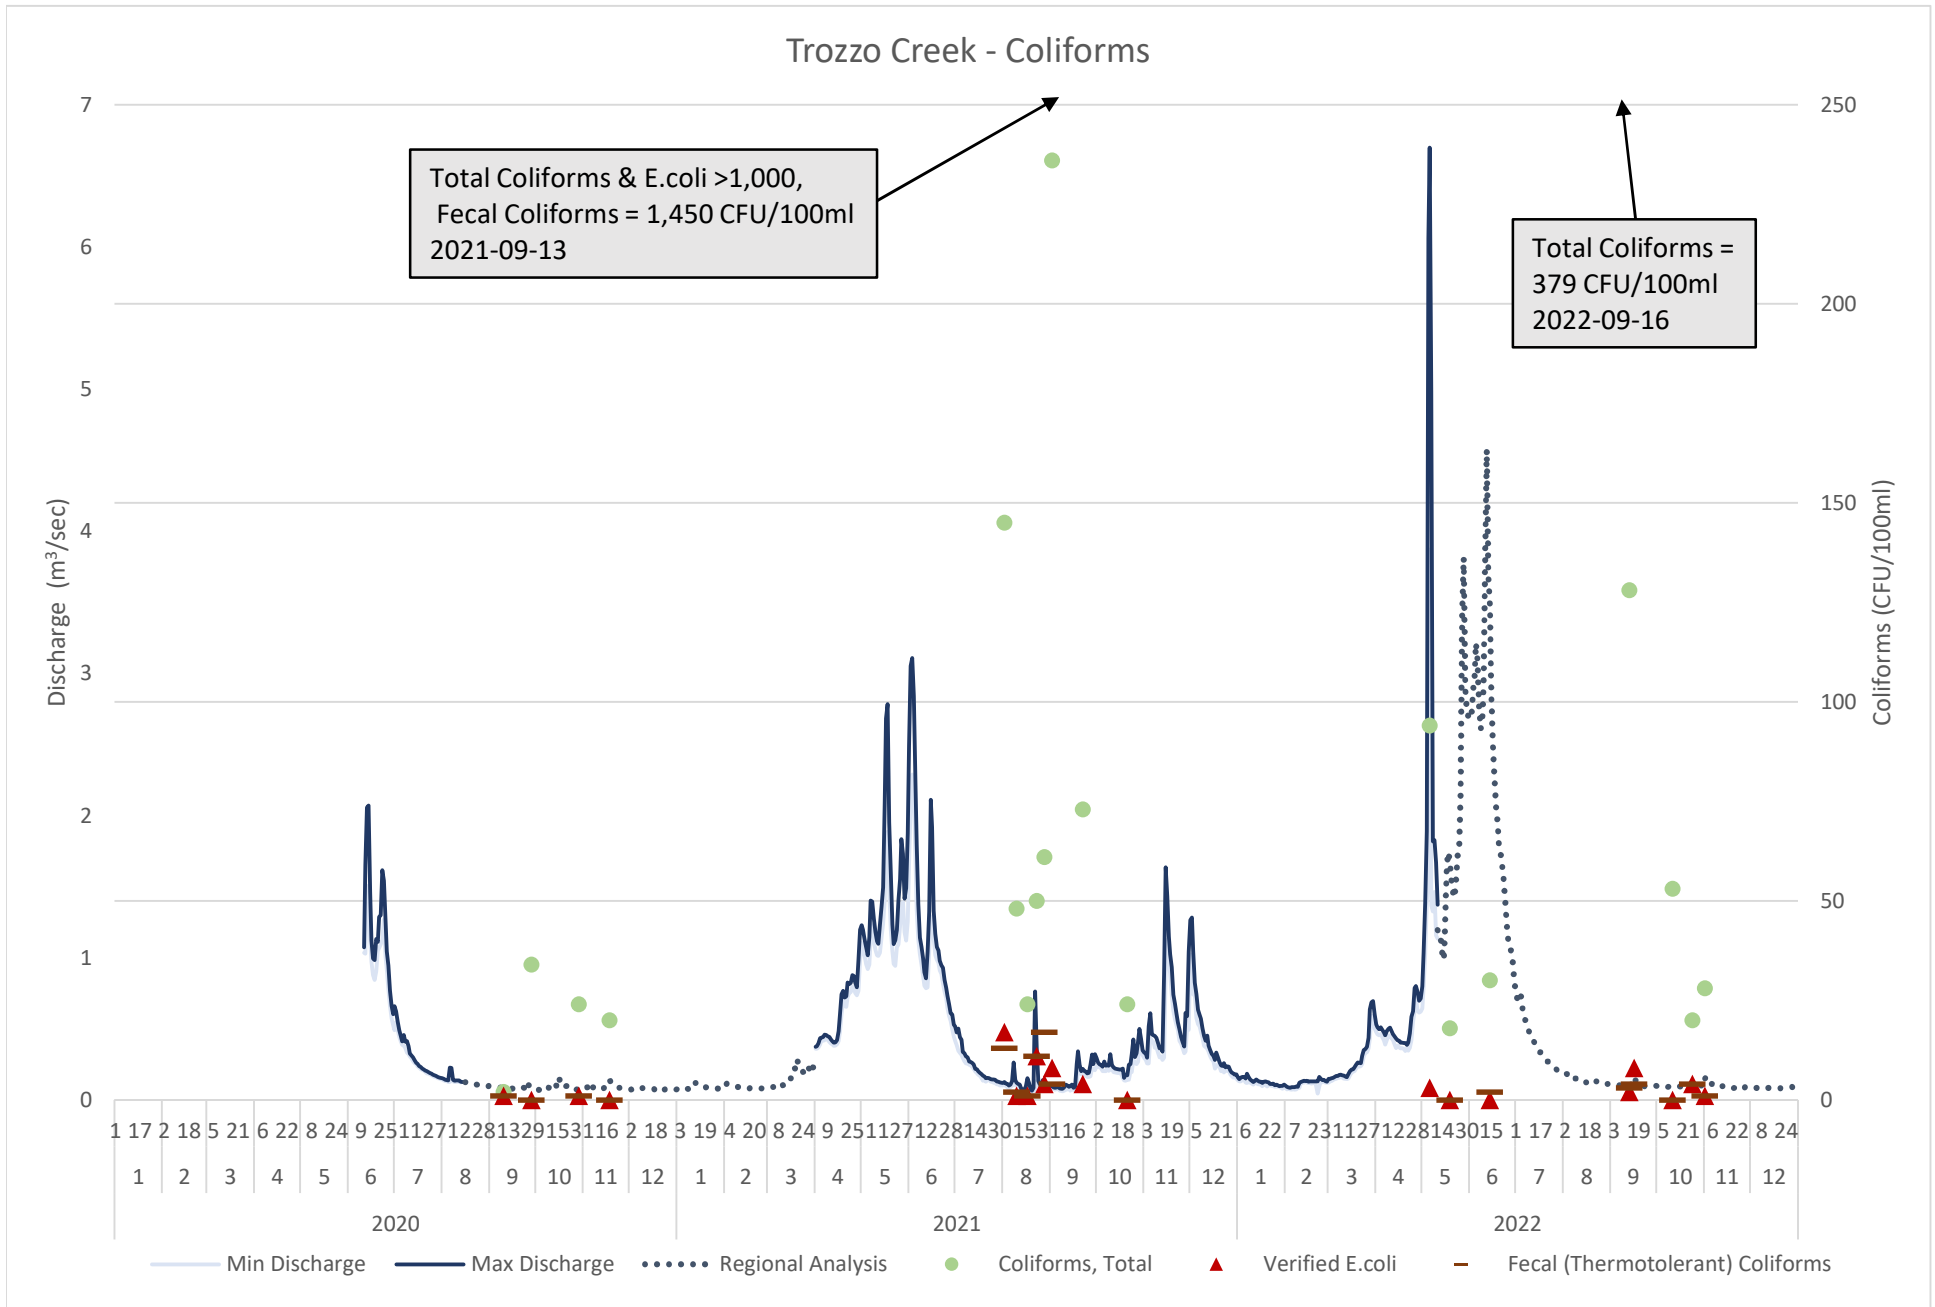
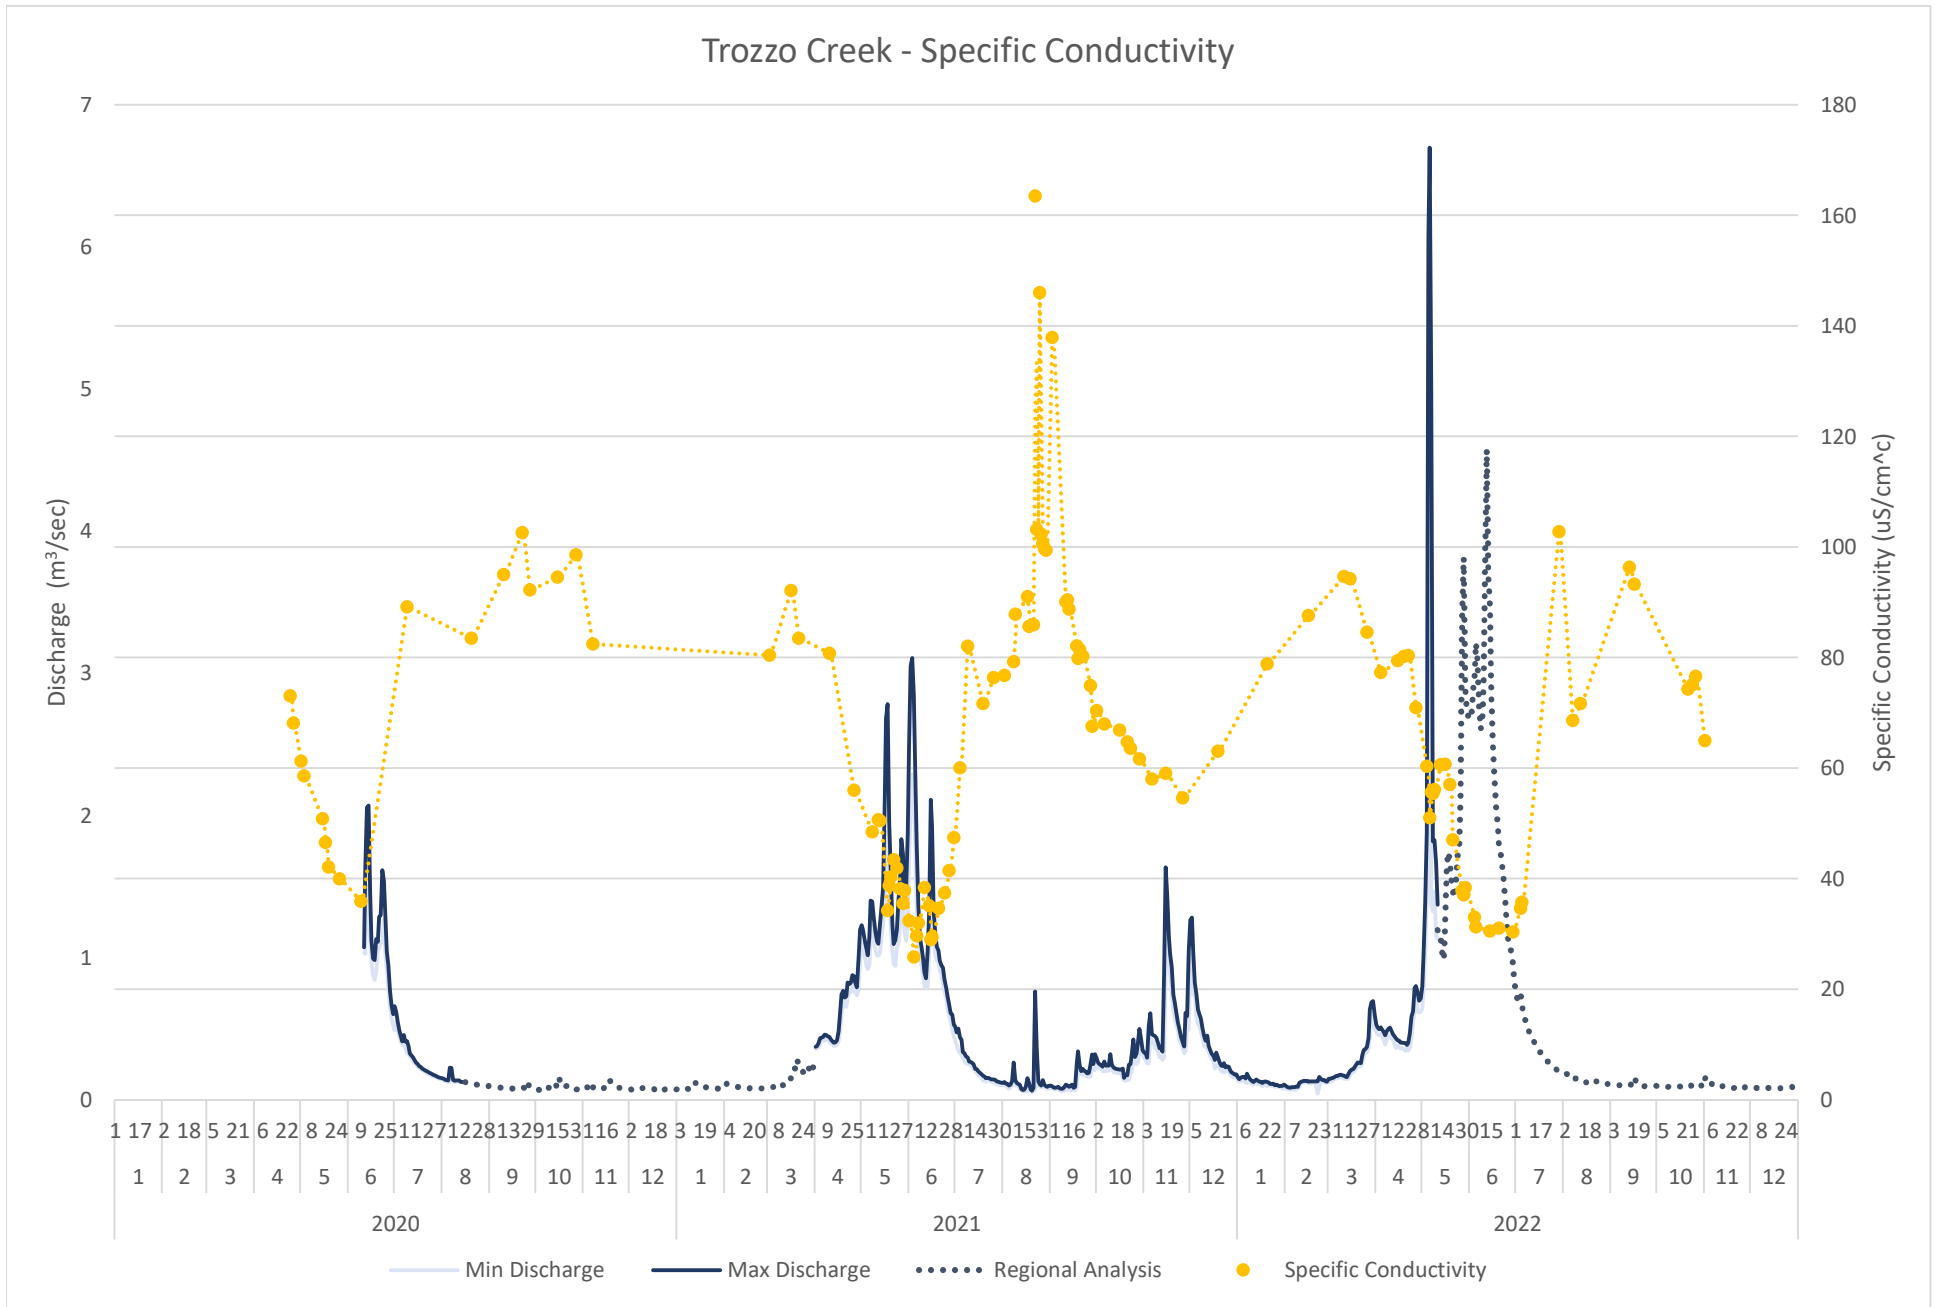
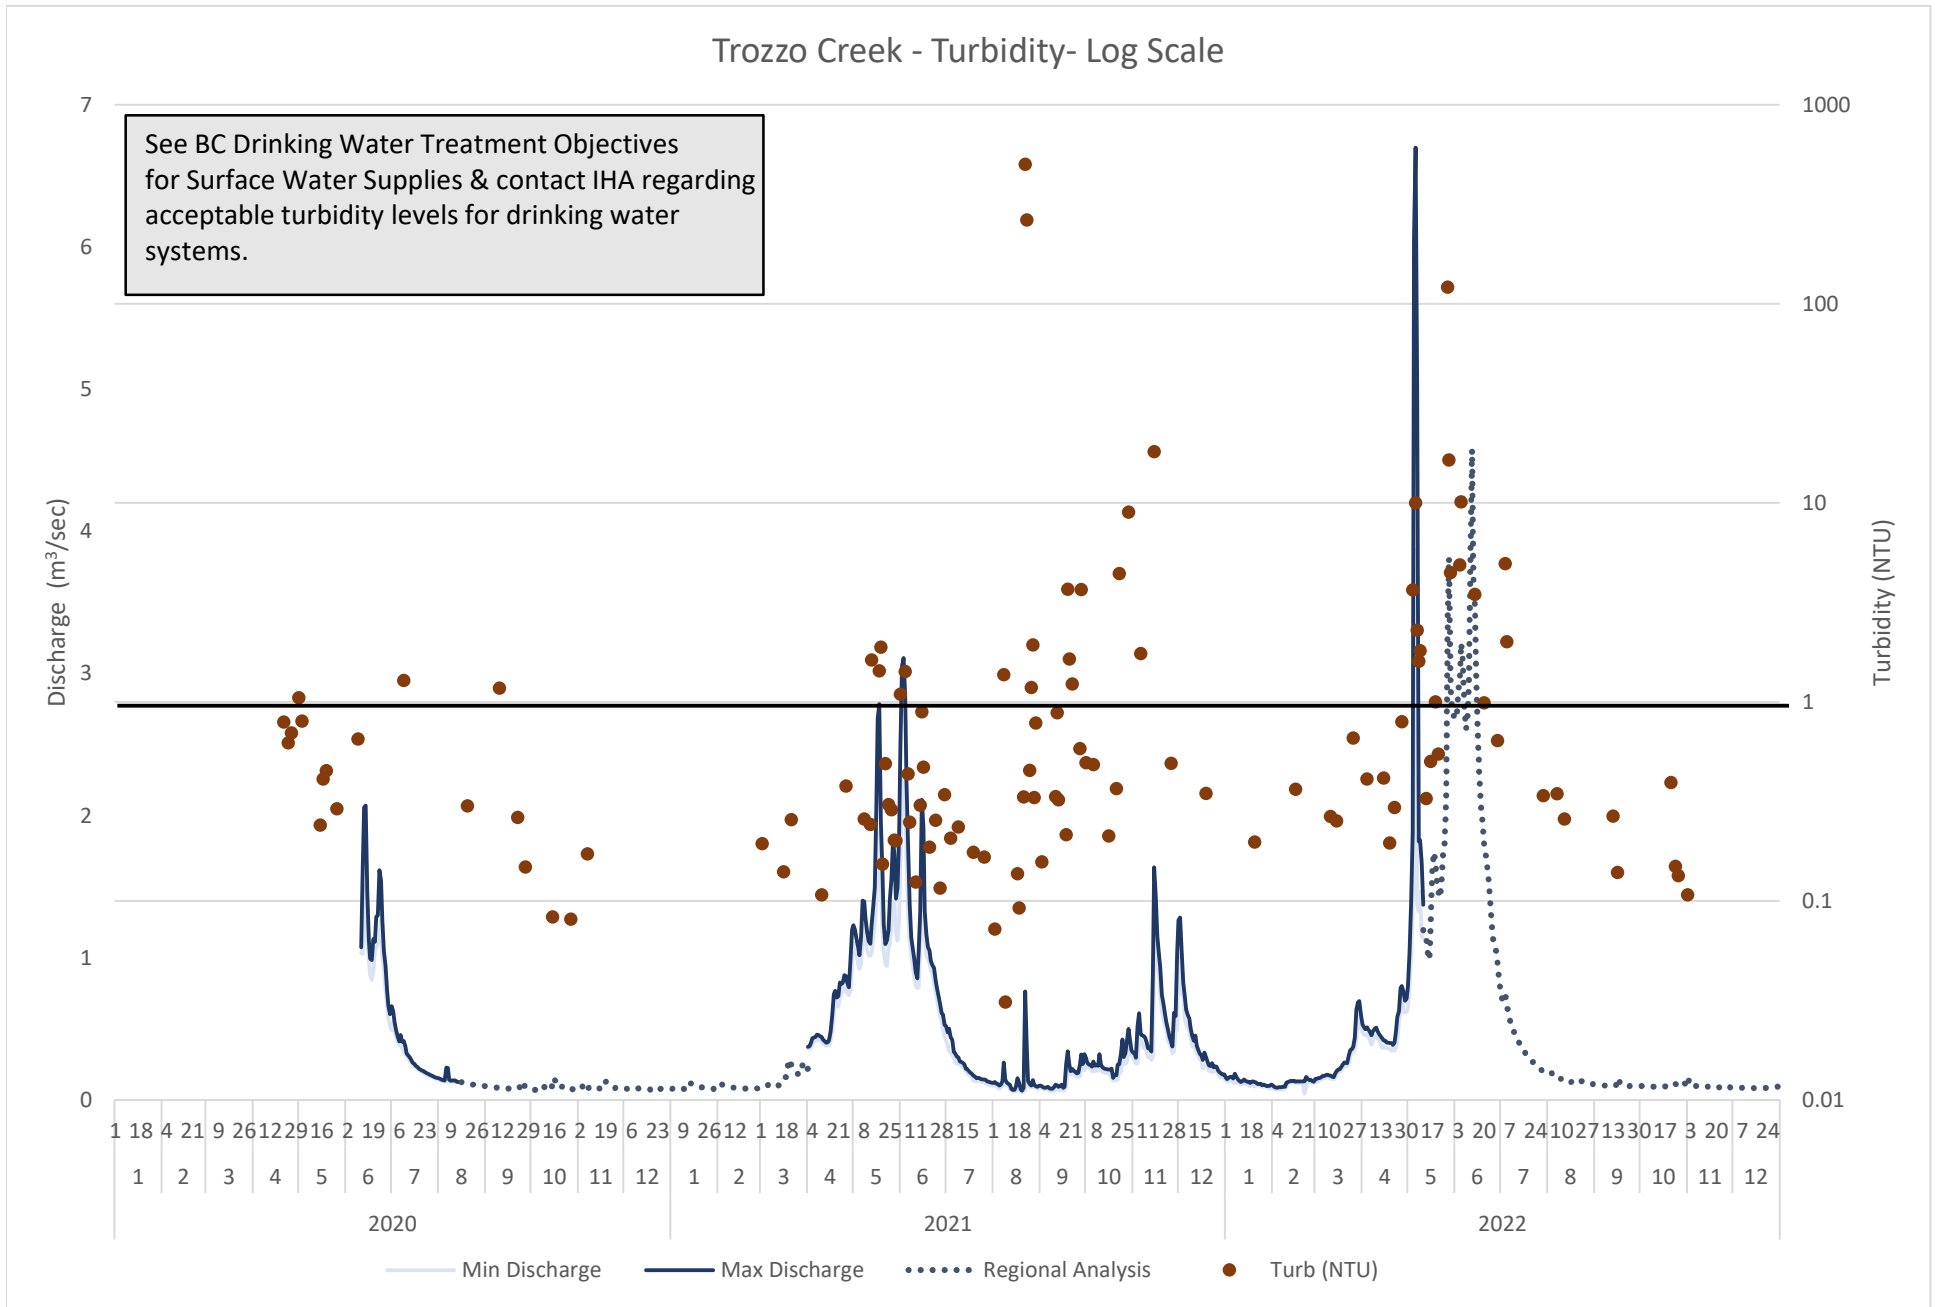
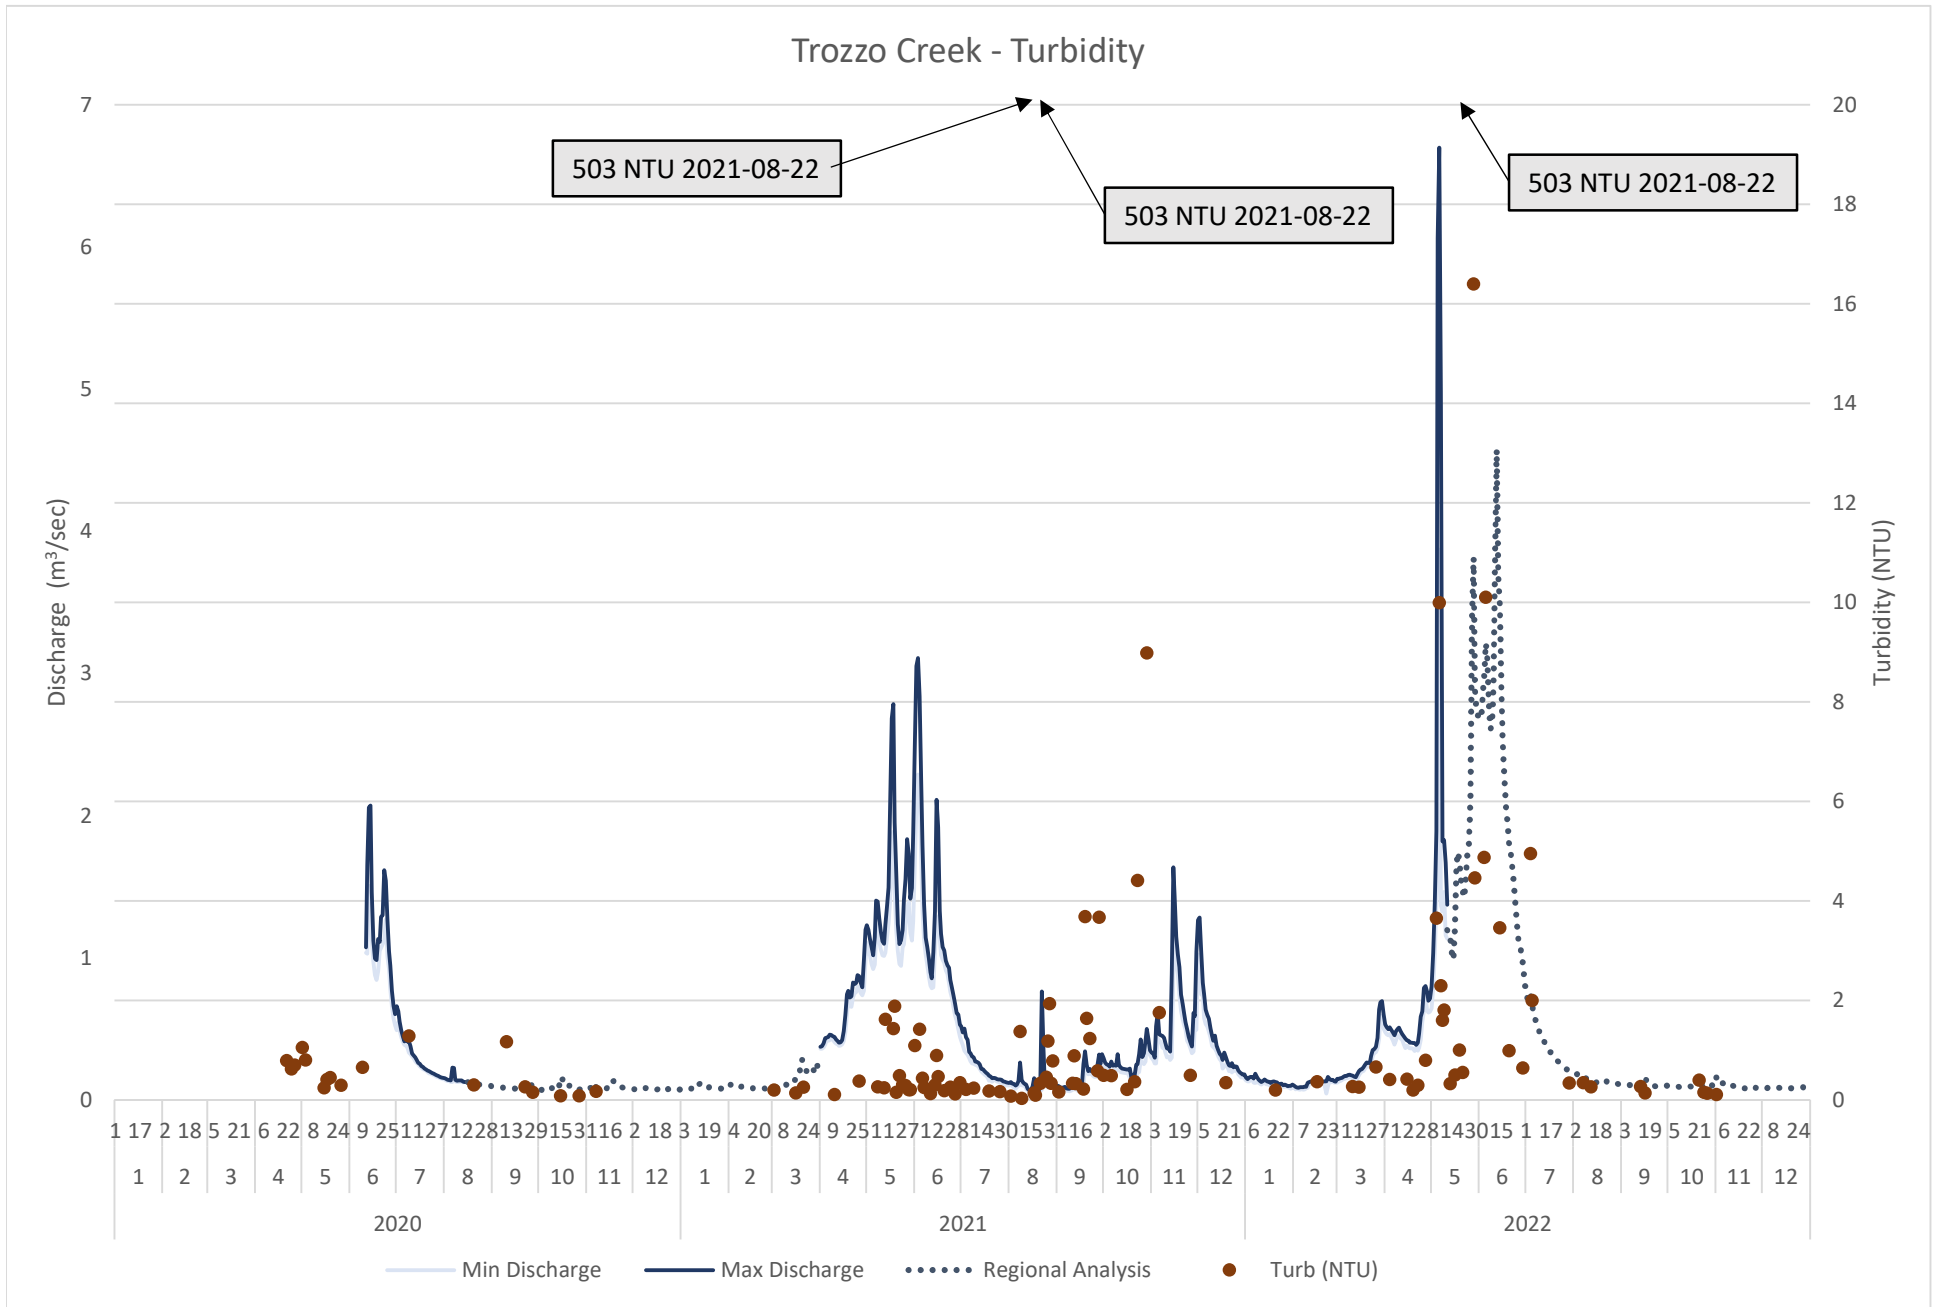
The following pages show the hydrograph, stage and water quality data over the current and past reporting periods.

The stage data is not shown as the data is not comparable due to two stations being used at Trozzo Creek, and two regional analyses being used to construct the hydrograph.

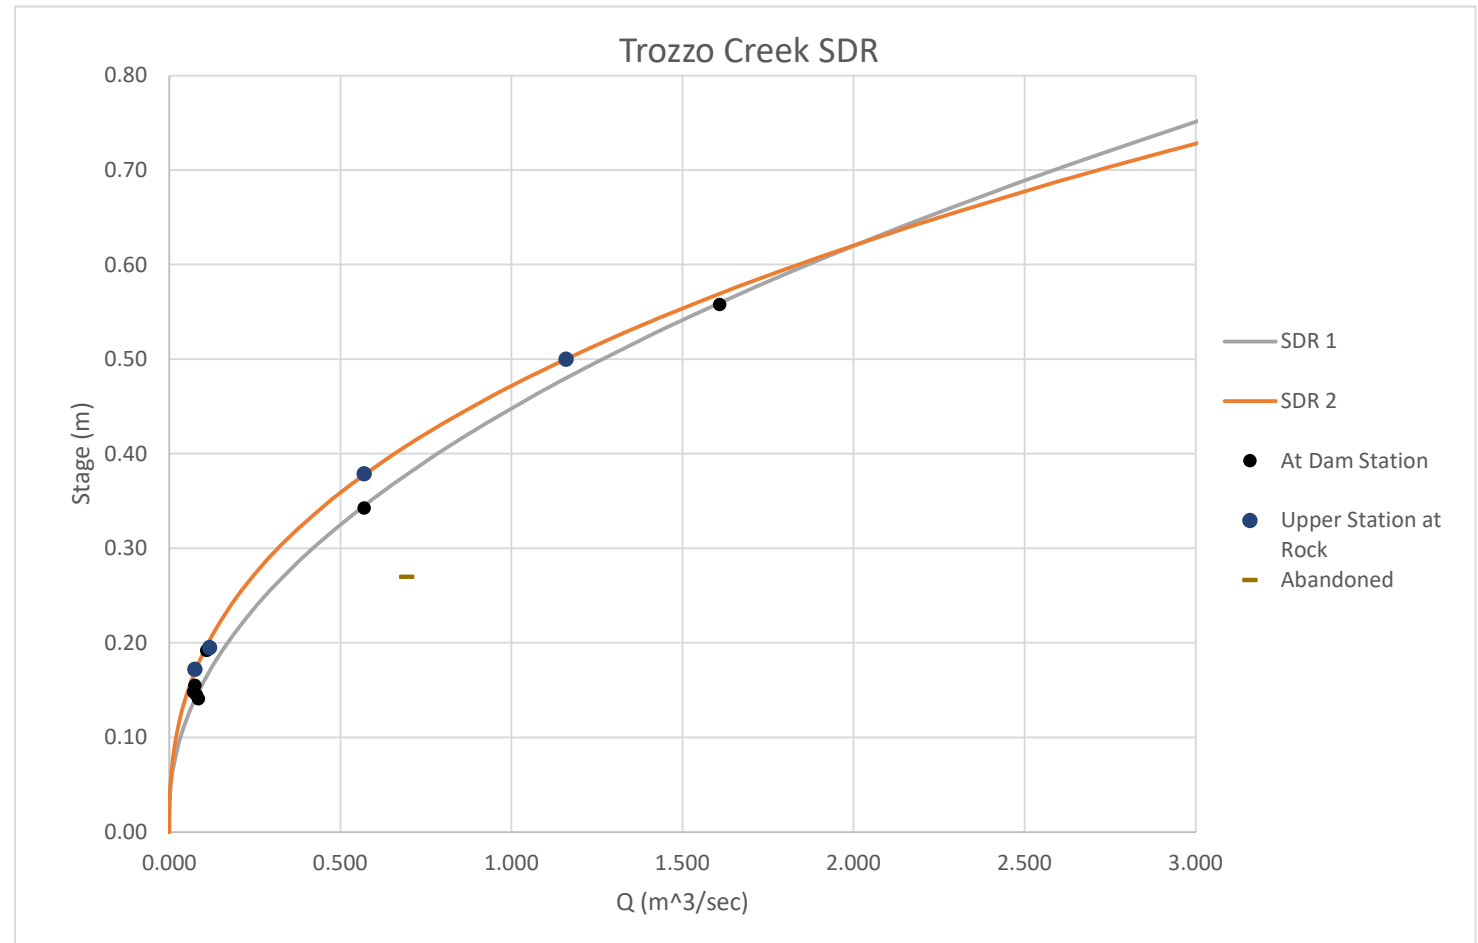
Both SDR #1, built for the station at the dam, and SDR #2, built for the upper station, are not considered unreliable as the controls regularly change. SDR #1 was built from stage data that was corrected due to changes in the control. All data is considered to be grade U (Unknown).

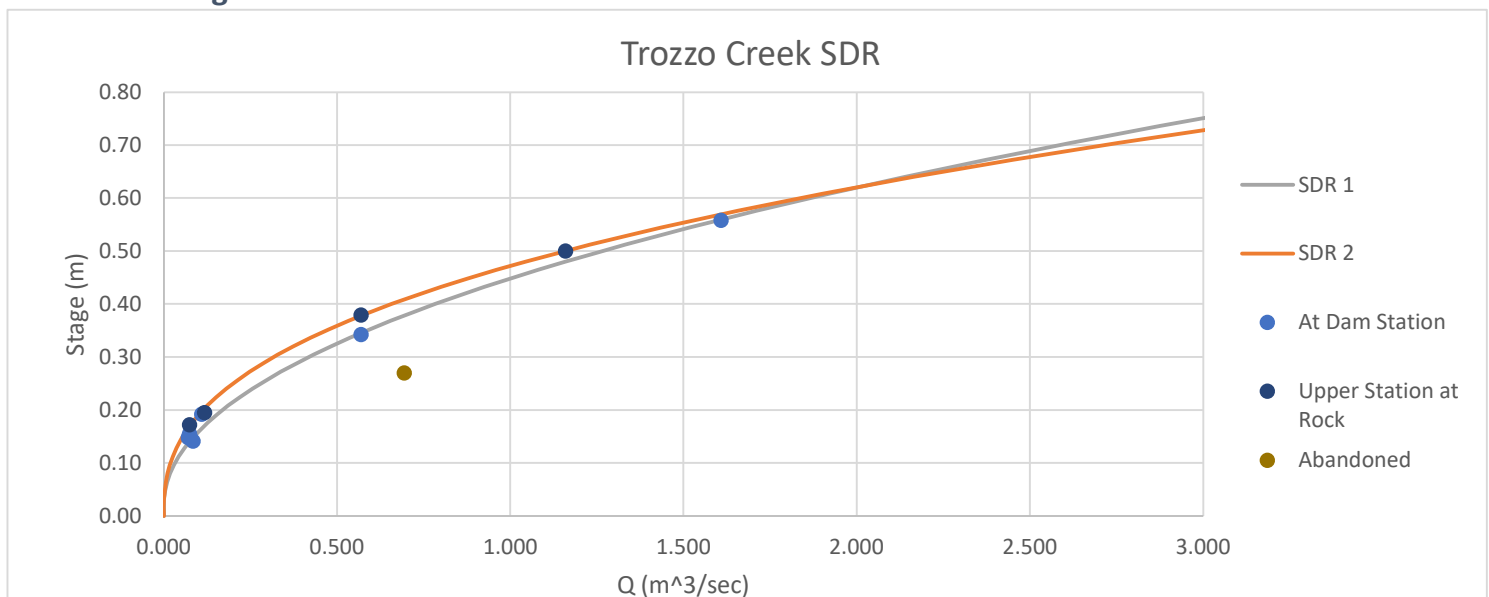
### SDR Curve Image:

#1  $Q = 5.69 * (H - 0.02)^{2.06}$       #2  $Q = 6.70 * (H - 0.0)^{2.53}$

**Remarks:** SDR #1 was constructed with level data from the "at dam" location, and SDR #2 was constructed with level data from the "upper station at rock". The stage data used in SDR #1 was adjusted due to residents damming the location to pool water at their point of diversions. Both SDRs are no longer applicable as multiple control changes have occurred. All data is considered to be graded as Unknown.
